# Illinois Roof Inspections

Re: Partial Inspection report for the Sample location roof at sample address, Schaumburg, IL.

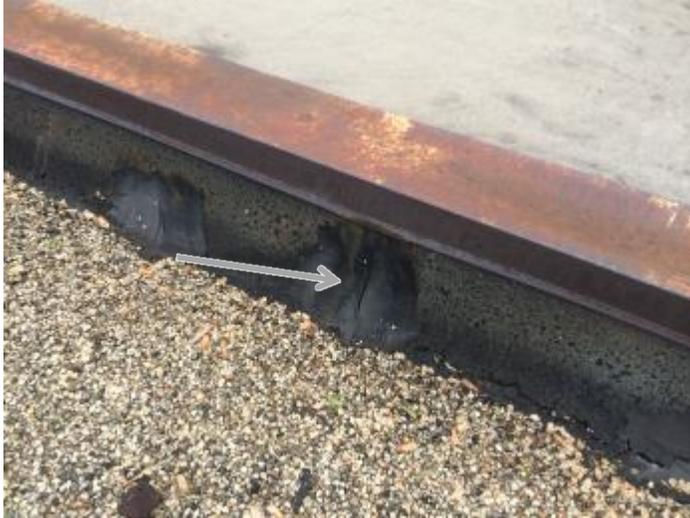
Failure of vertical seam in wall flashing. Also shows rusted coping.

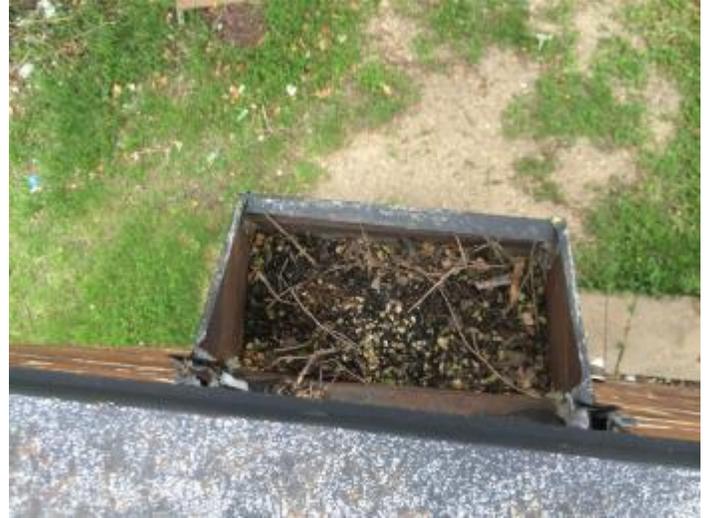
South wall scupper collector box filled with debris. Recommend periodic maintenance to clear collector box.

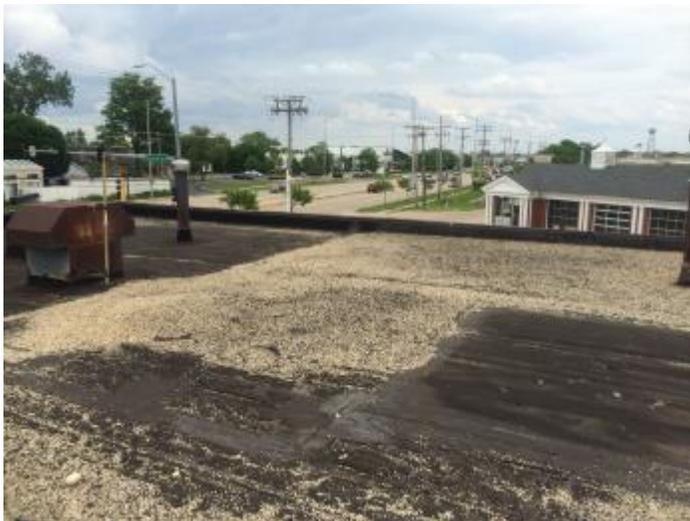
Numerous areas of repair over more than half the roof area can be seen. Numerous areas of the roof were soft and spongy to walk upon, likely indicative of damaged insulation beneath the roof membrane.

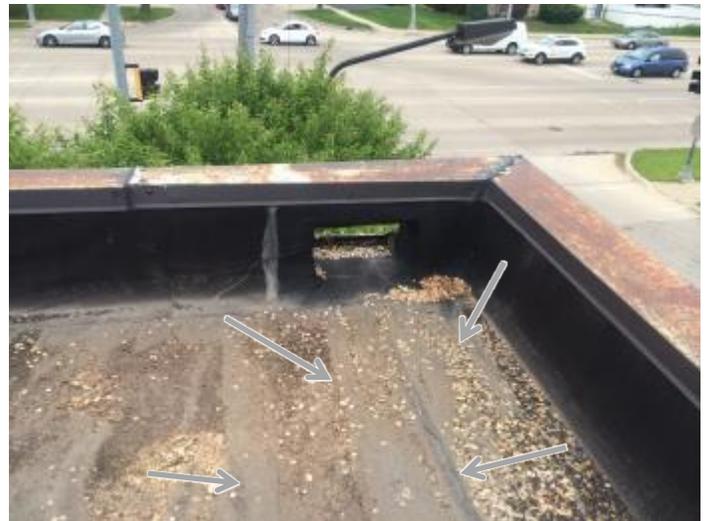
Ridging and wrinkling in roof membrane near scupper. This is likely indicative of failure of adhesion between the insulation or cover board beneath from the membrane.

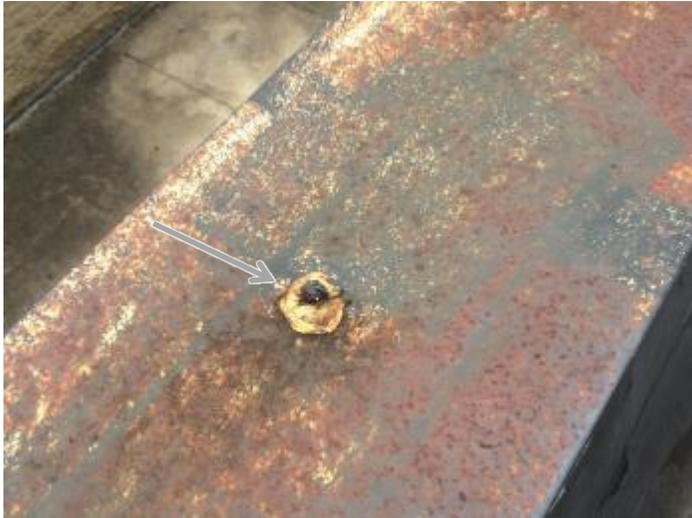
Existing copings not properly installed. Holes were drilled into the metal coping to allow for the anchor bolts beneath to penetrate through. Then sealant was applied, which has failed. Anchor bolts will need to be trimmed or buried so that new coping has no penetrations.

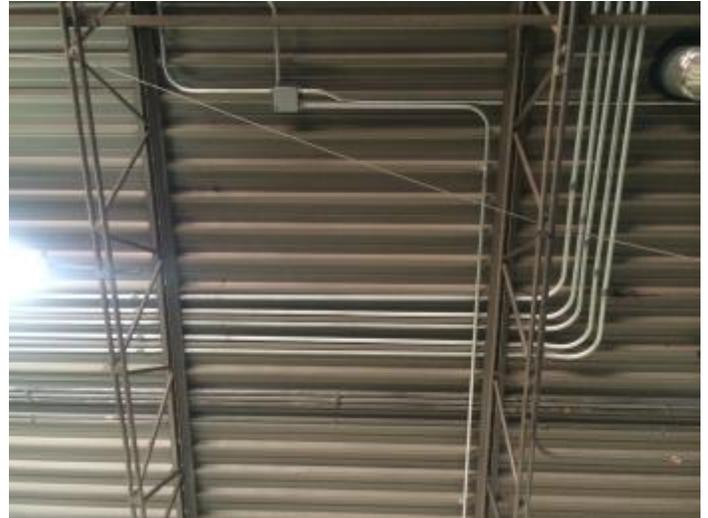
Conduits beneath the roof decking were installed within the roof flutes. Special care will need to be taken to locate and mark these conduits, so that fastening patterns may be adjusted to prevent penetration with fasteners into the conduits.

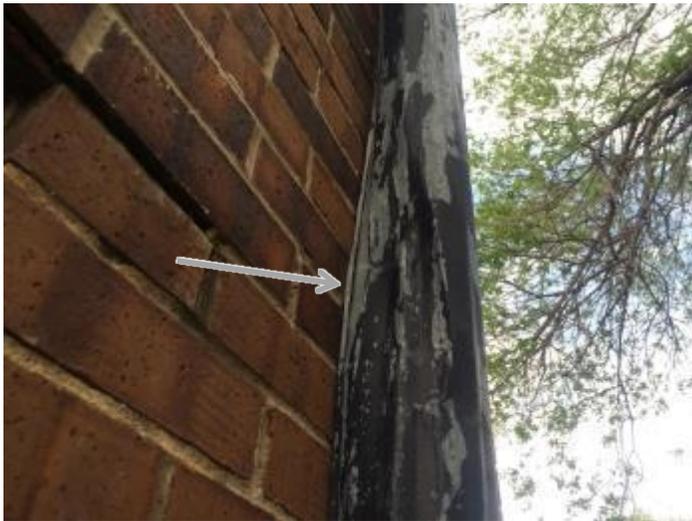
Existing downspout at the South wall has split, likely from ice expansion. Recommend a plumber inspect the drain below grade.

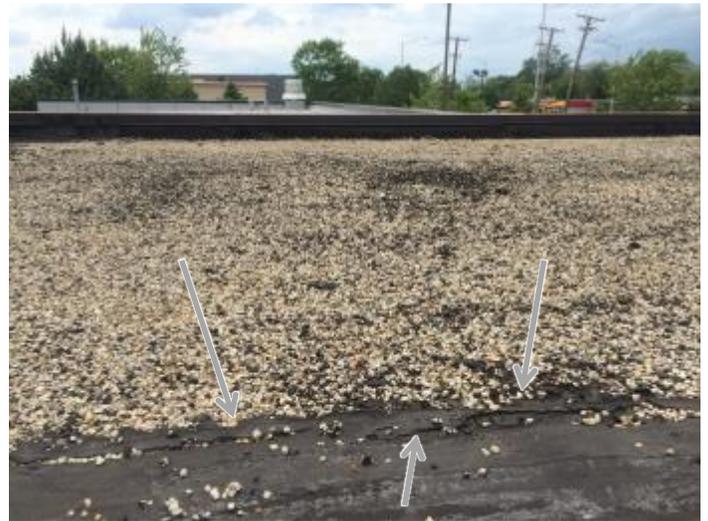
Failure at joint where repairs meet existing roof allowing water infiltration into the roofing assembly, and causing vapor blisters within the roofing membrane.

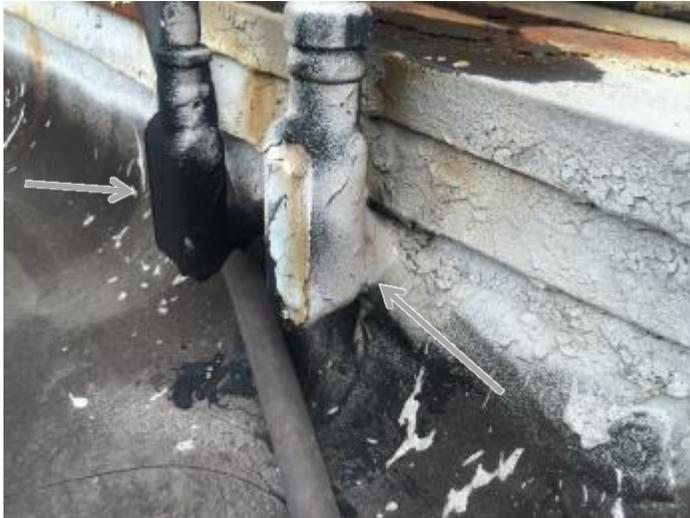
Conduit junction boxes penetrate through the side of the curb. Recommend junction boxes be relocated before roofing is installed so that they may be properly flashed.
