# Illinois Roof Inspections

June 7<sup>th</sup>, 2015

Re: Inspection report for the Sample Condominium roof at 1234 Sample Ave., Chicago, IL.

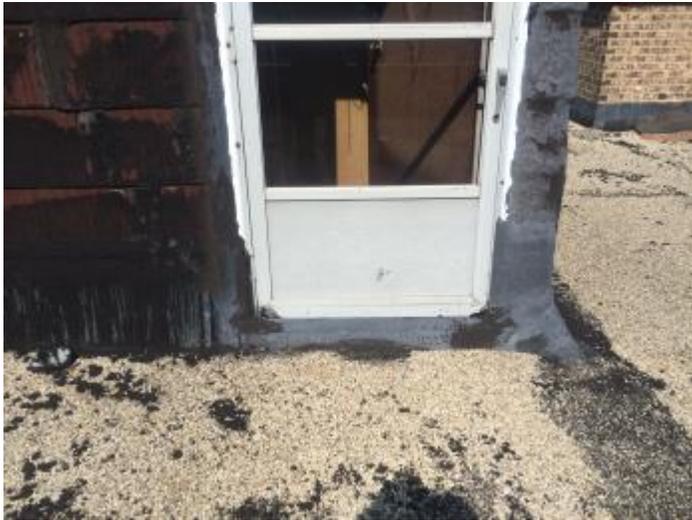
The access door to the roof appears to have been repaired numerous times. This door should be replaced by a qualified carpenter at the time of roof replacement.

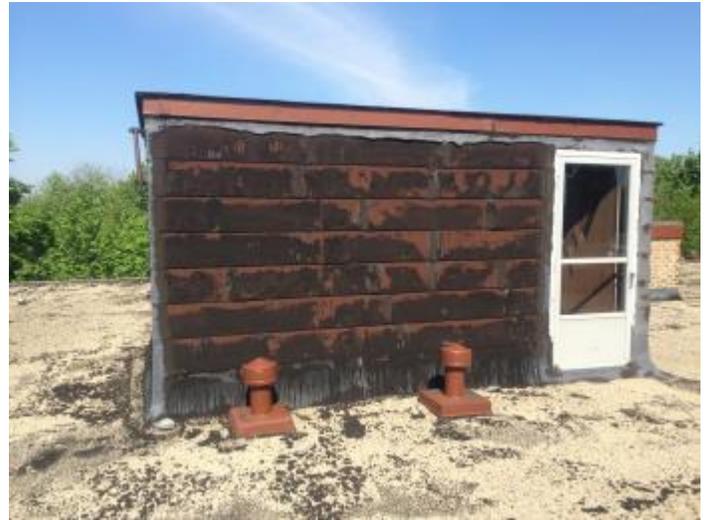
Asphalt siding on the stairway pent house is in very poor condition. Recommend replacement of this siding at time of roof replacement.

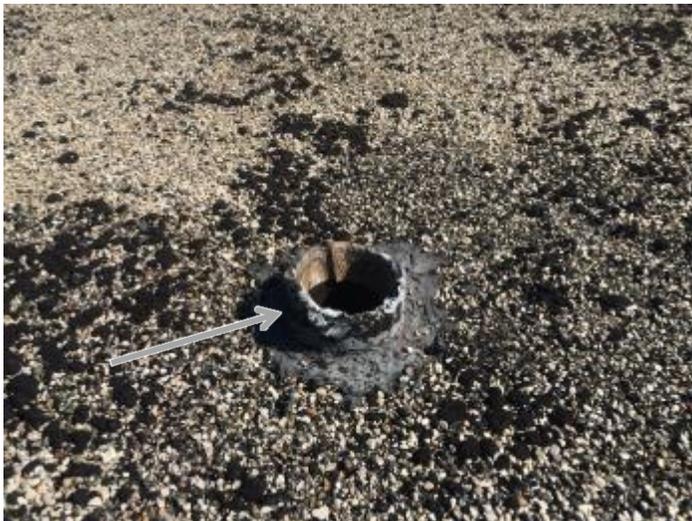
Plumbing vent pipes are very low to the roof surface. This is due to the tapered insulation installed as a secondary roof to alleviate issues with standing water on the original roof. It will be required that numerous plumbing vent pipes be raised by a qualified plumbing contractor at time of roof replacement.

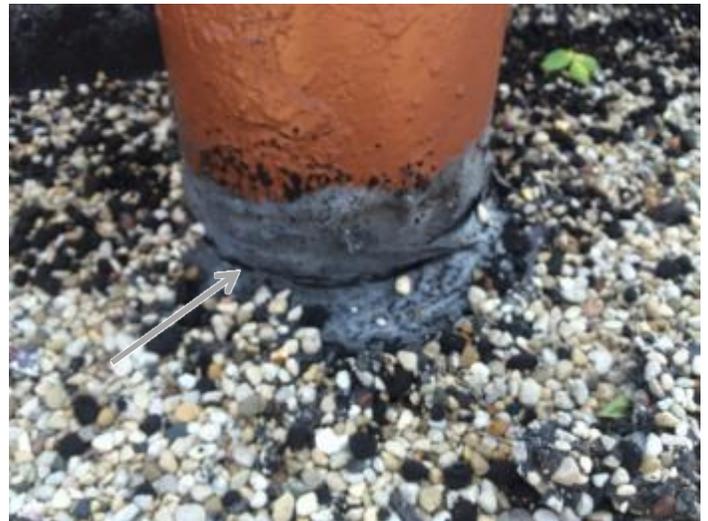
Cracks at sealant was observed at nearly every vent pipe allowing water to infiltrate into the roofing assembly. This is likely due to lack of fabric reinforcement in the applied mastic and failure to remove gravel before applying mastic sealant. When the roof is replaced each vent pipe should be properly flashed.

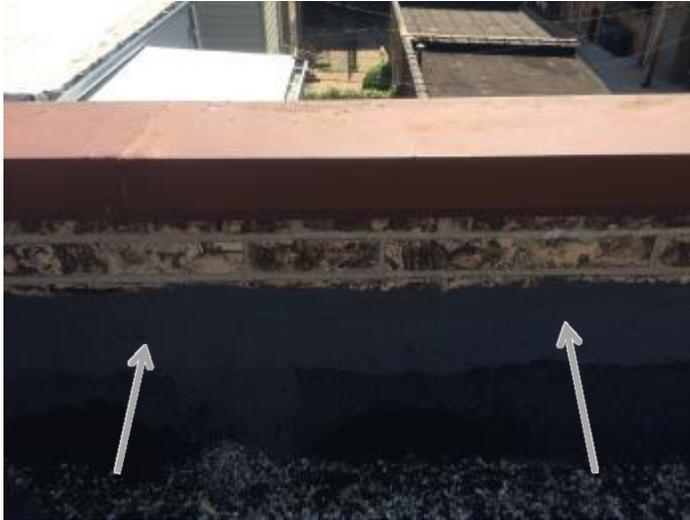
Lack of mechanical termination at parapet walls and observed previous repair indicating roofing has begun to fall from wall. When new roof installed membrane should completely wrap up and over the top of the parapet wall.

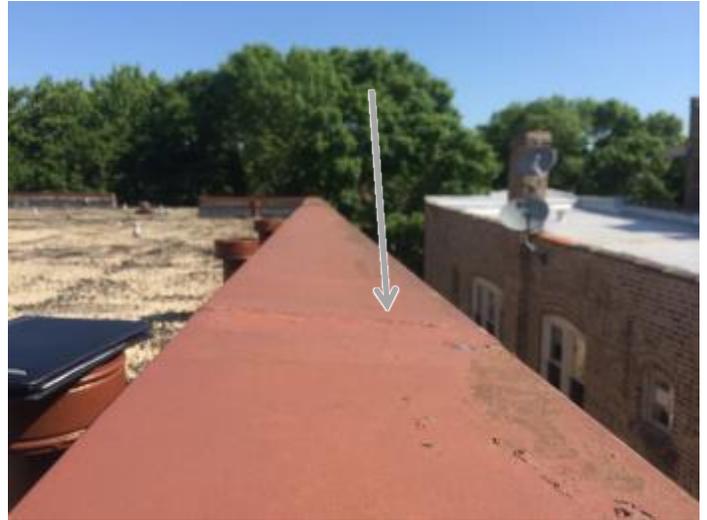
Existing metal coping was improperly installed back pitched so that water drains away from the roof. Industry standard is for water to drain to the roof at approximately 1/4" per foot. When new roof is installed copings should be replaced.

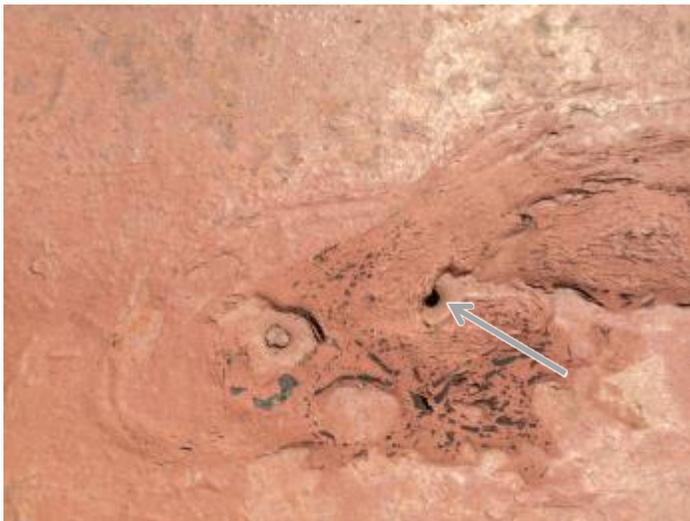
Holes in the metal coping was observed at time of inspection. Previous repair attempts were made at these holes.

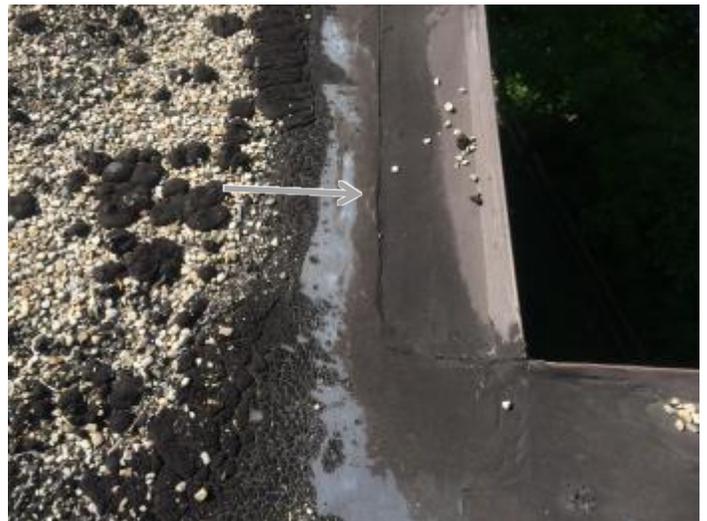
Gravel stop at roof edge appears to be improperly sealed with mastic and no fabric reinforcement. The seam has cracked and is allowing water to enter into the roofing assembly.

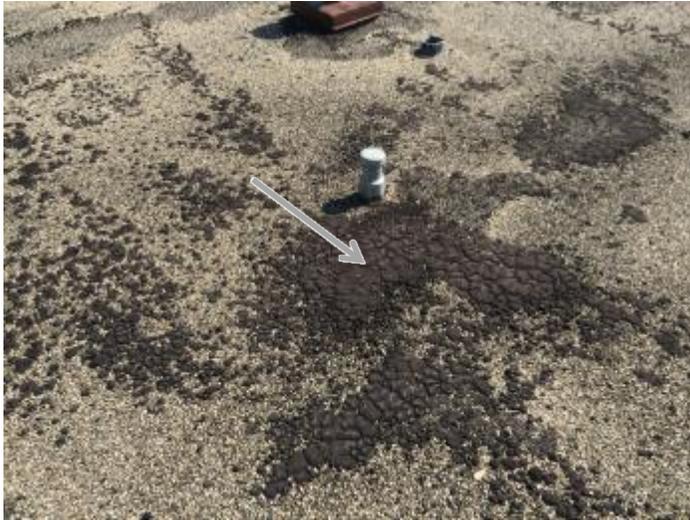
Alligatoring in the roofing membrane was observed throughout the roof. This is likely due to excessive asphalt application when the roof was installed or more likely due to inadequate gravel installation or gravel erosion. Membrane has begun to crack at areas of alligatoring due to UV exposure.

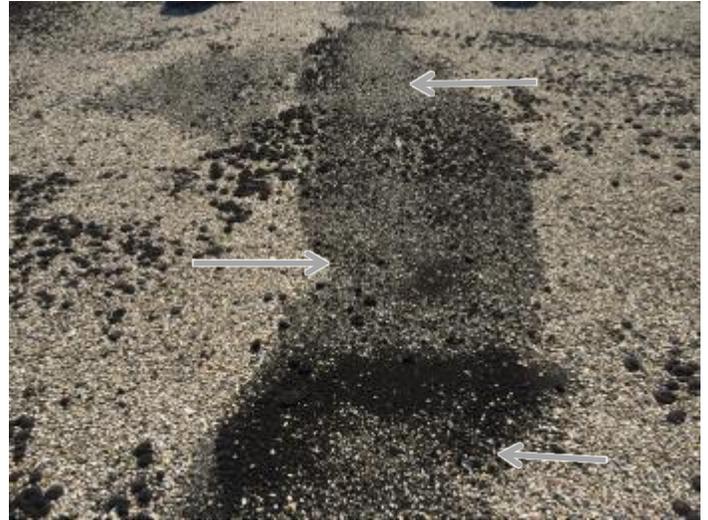
Numerous Vapor blisters were observed at time of inspection. This is a separation of layers likely caused by trapped moisture within the roofing assembly.

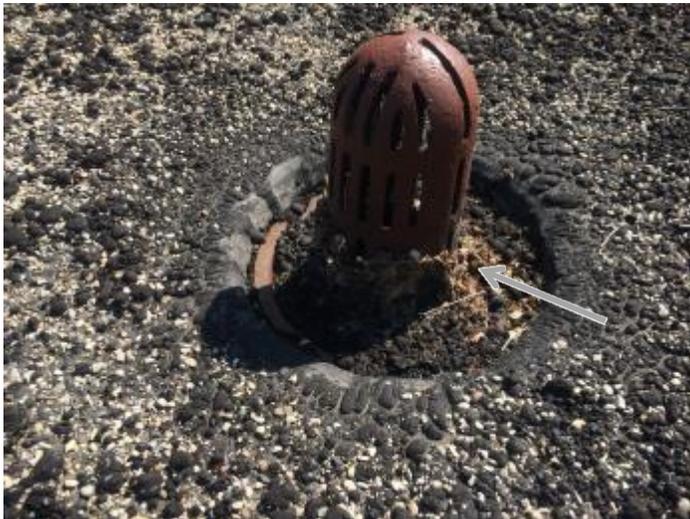
Some existing drain pipes were observed with blockages. Recommend a Sullivan Total Maintenance Package to periodically clear drains of debris.

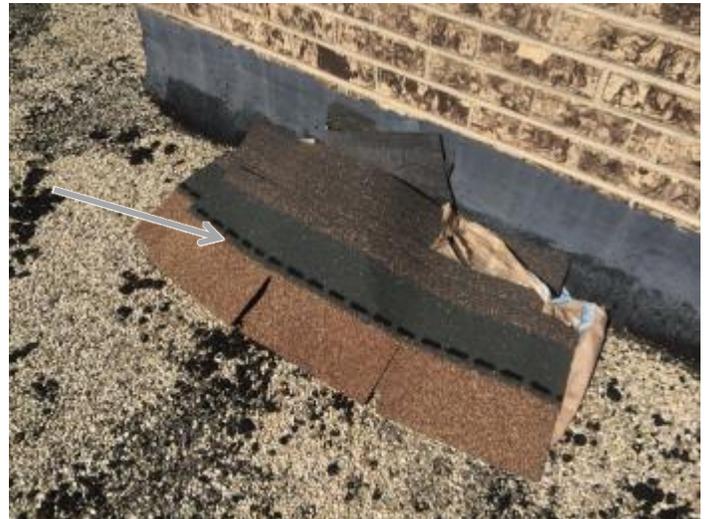
Asphalt shingles were left on the roof at the time that the asphalt shingle mansard roof was replaced. Recommend remove debris from roof.

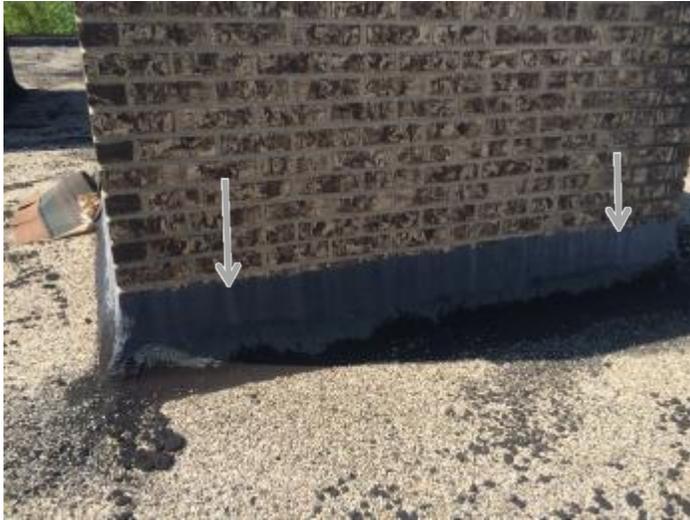
No mechanical termination was observed at the elevator over run and previous repair with mastic is visible likely an indication that membrane has fallen off the wall in the past. When the new roof is installed a mechanic termination such as metal termination bar and/or counter flashing must be installed.

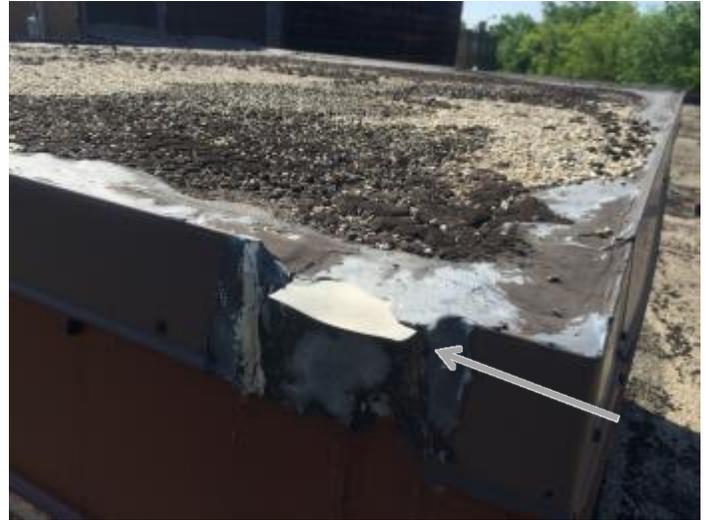
Improper drainage detail at elevator over run roof. Recommend installation of new self flashing gutter at two sides of elevator shaft roof, and two sides of pent house stair roof.

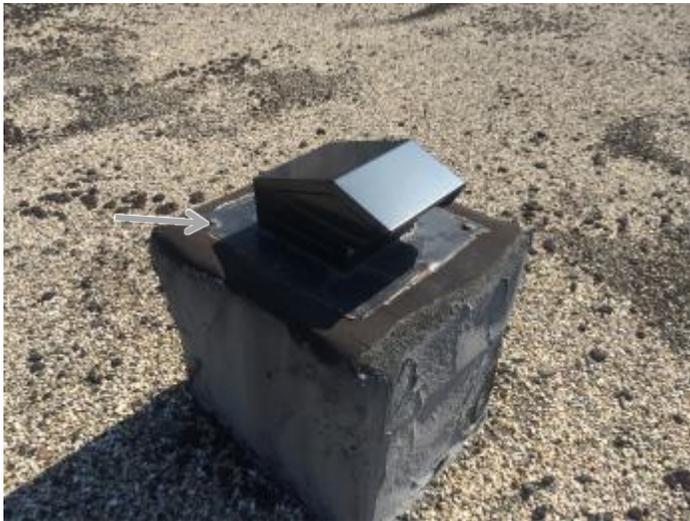
Improper installation of kitchen or bathroom exhaust vent. This vent is designed for use on shingle roofs. Furthermore sealant at fasteners has begun to fail. A qualified ventilation contractor will be required to install proper ventilation so that roofers may install a proper water tight detail at this vent.

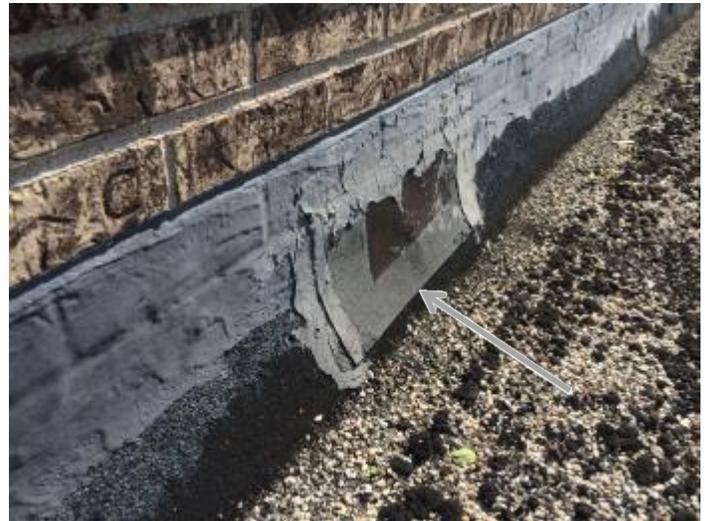
Installation of membrane patch at parapet wall flashing.

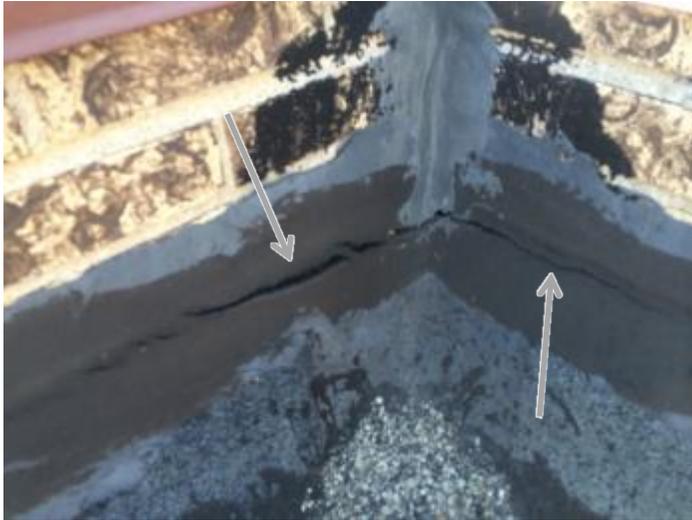
Roofing membrane has fallen from the parapet wall due to lack of mechanical termination. Also evident is the previous repair attempts. At parapet wall, membrane should wrap up and over the top of the parapet walls. At elevator shaft and stair pent house, a metal termination bar and/or counter flashing will be required.

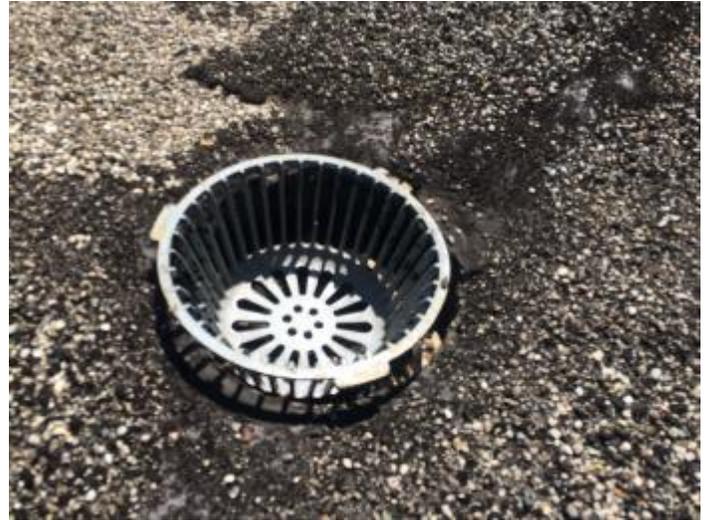
Existing strainer basket at drain installed up side down allowing debris to enter into the drain pipe.

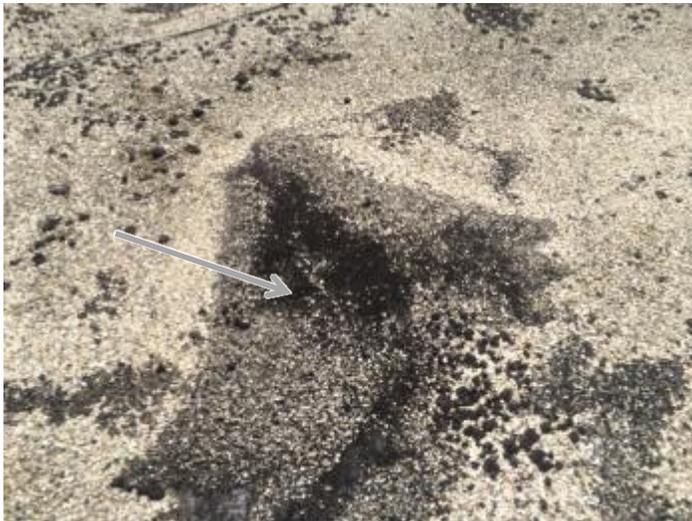
Numerous Vapor blisters were observed at time of inspection. This is a separation of layers likely caused by trapped moisture within the roofing assembly.

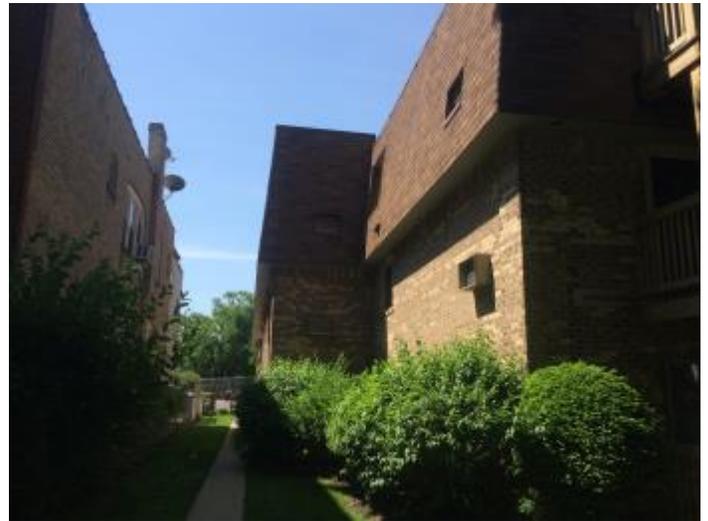
The asphalt shingle mansard roof appears to be in fair condition. Though a thorough inspection of this roof was not completed, some possible minor sagging of the shingles may exist on the West side.
