# Illinois Roof Inspections

June 3<sup>rd</sup>, 2015

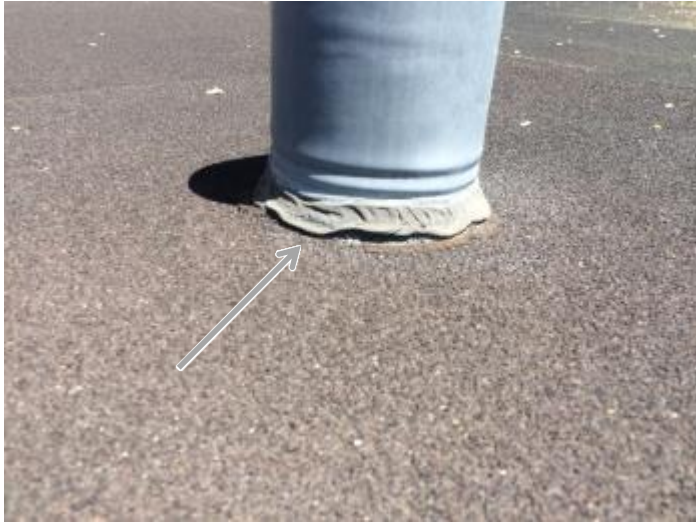
Shrinking or improperly applied sealant at base of pipe flashing. Recommend properly apply new sealant.

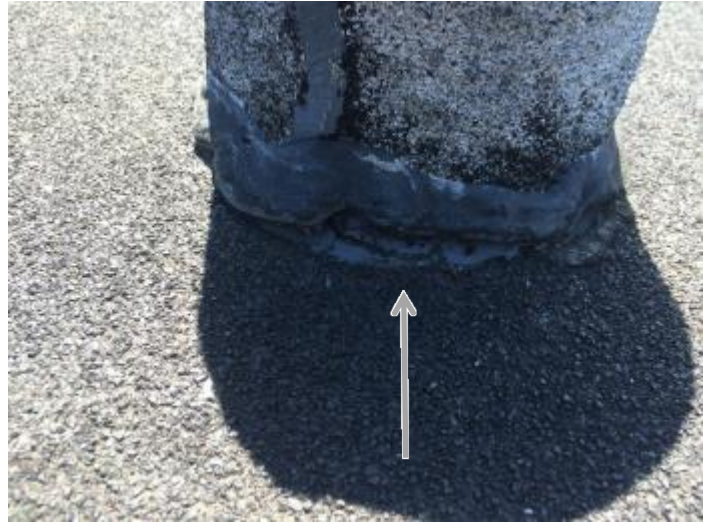
Shrinking or improperly applied sealant at base of pipe flashing. Recommend properly apply new sealant.

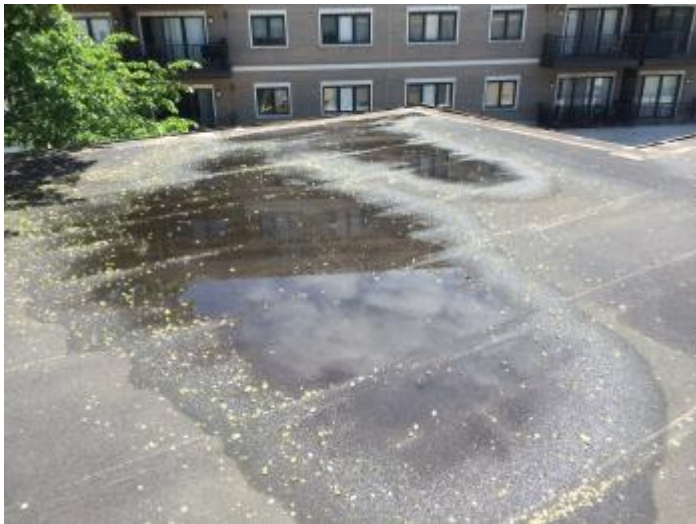
Standing water at roof edge. Recommend sweep roof, inspect seams and repair as necessary.

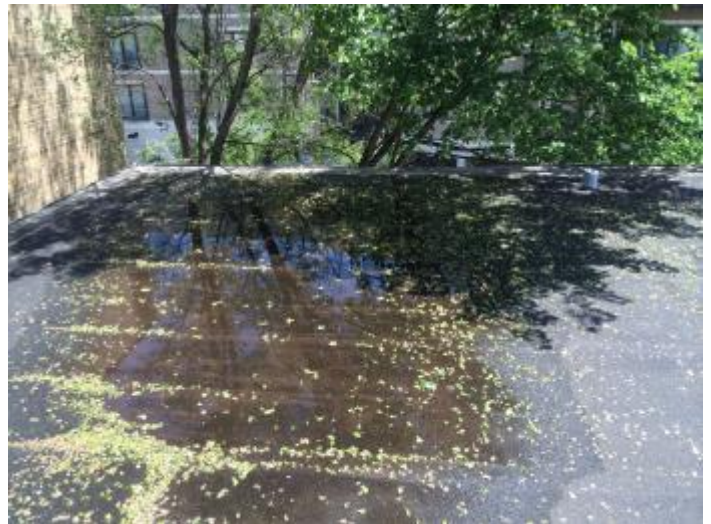
Standing water at roof edge. Recommend sweep roof, inspect seams and repair as necessary. In addition ensure tree is always pruned away from building to prevent damage to roof.

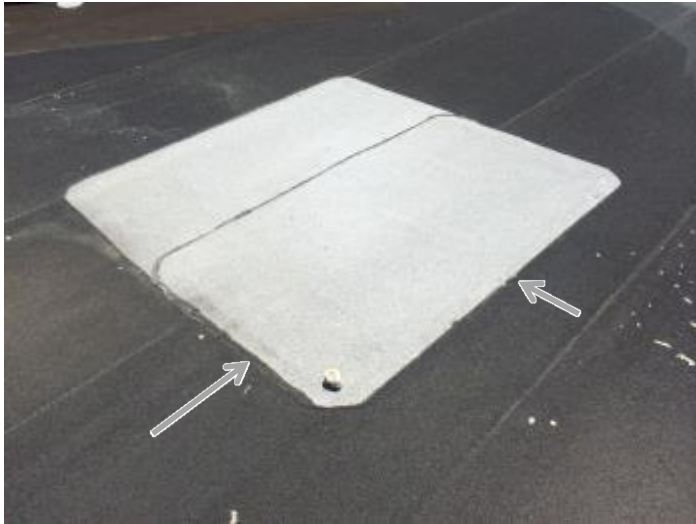
Previously installed roof patch. Recommend probe seams to ensure proper adhesion and repair as necessary.

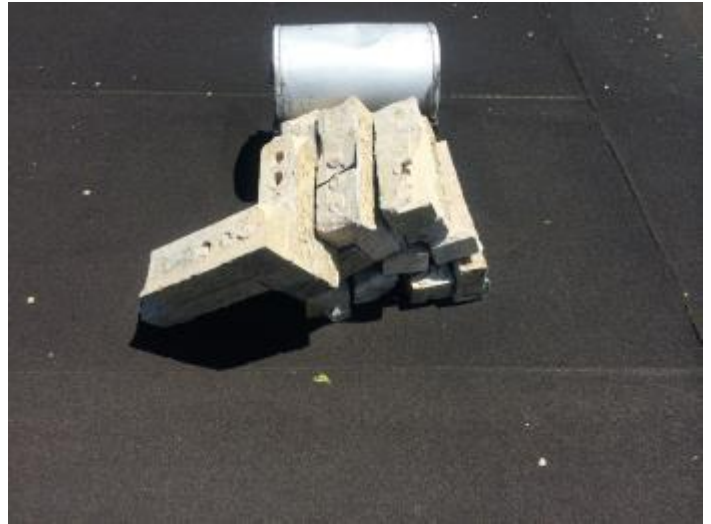
Debris left on roof. Recommend remove bricks and dispose.

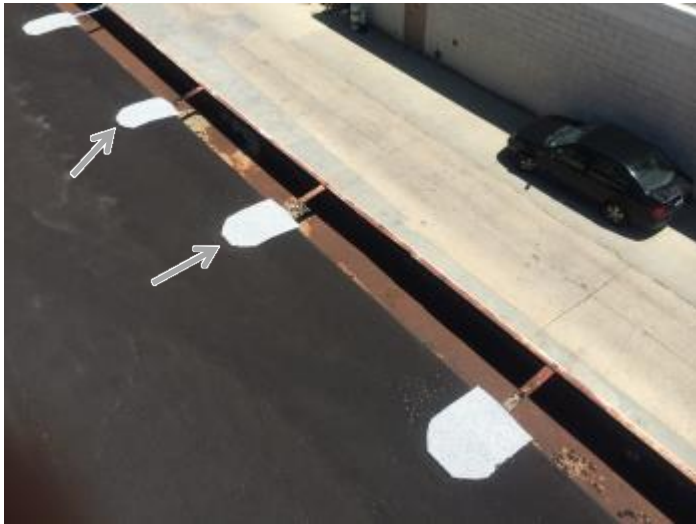
Previously installed repair at gutter edge.

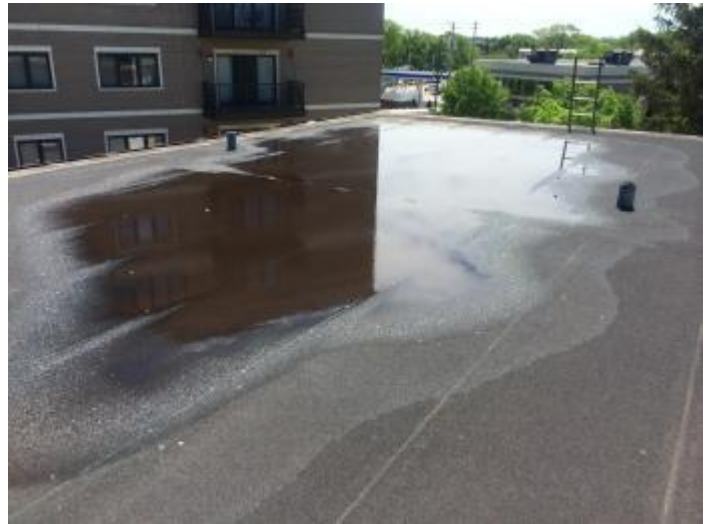
Standing water at roof edge. Recommend sweep roof, inspect seams and repair as necessary.

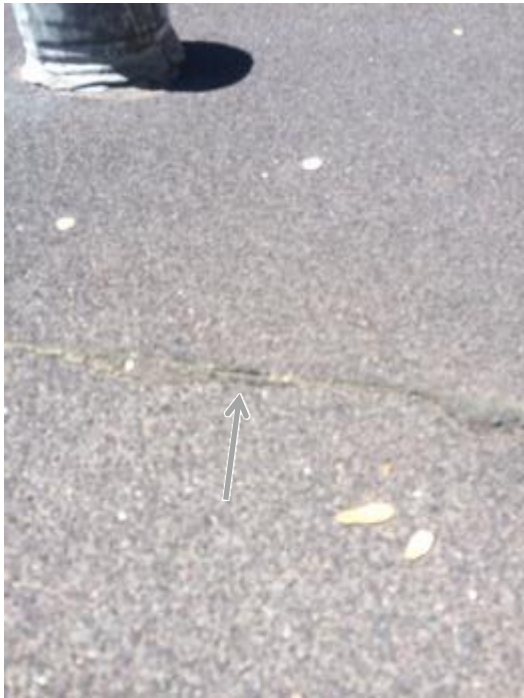
Lap seam around target flashing, granules do not appear to have been properly imbedded causing loss of adhesion and void at seam. Recommend inspect all end laps and flashing seams and repair as necessary.

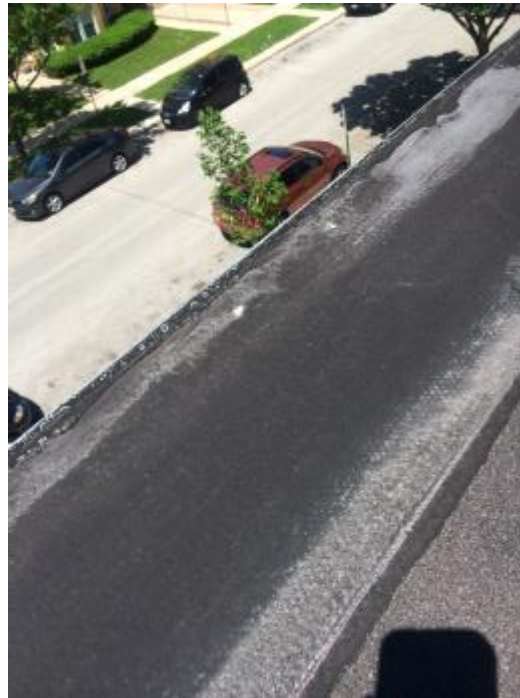
Previously installed repair at metal perimeter flashing.

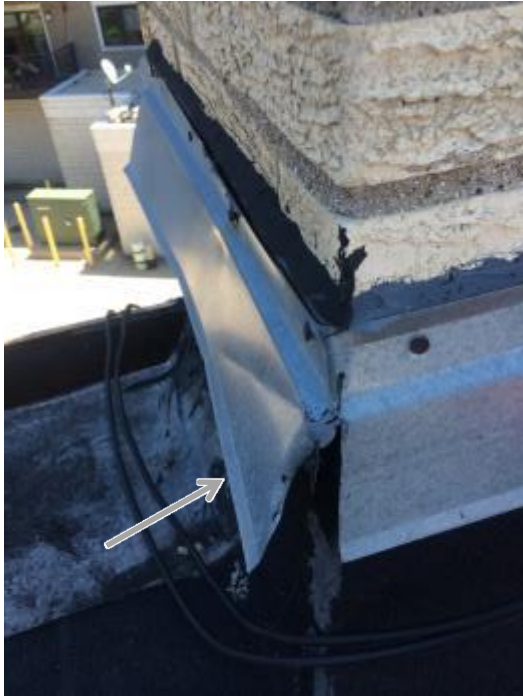
Metal chimney flashing damaged, and sealant cracked. Recommend replace loose flashing and apply new sealant.

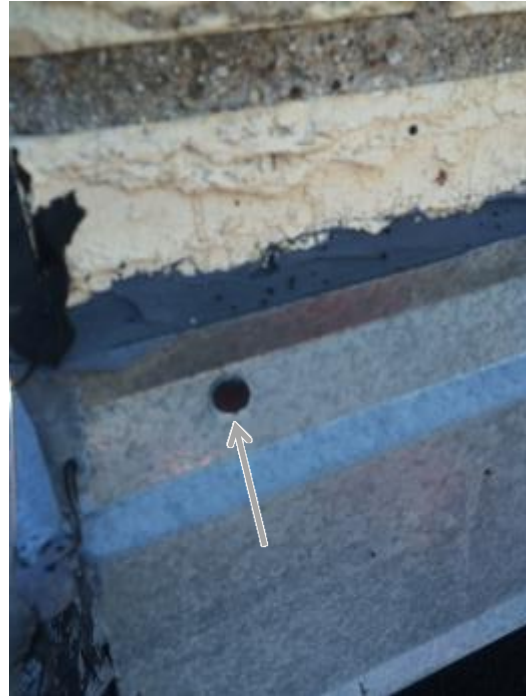
Exposed nails at metal chimney flashing. Nails are not the proper fastener for this application. Recommend replace improperly installed chimney flashing and apply new sealant.

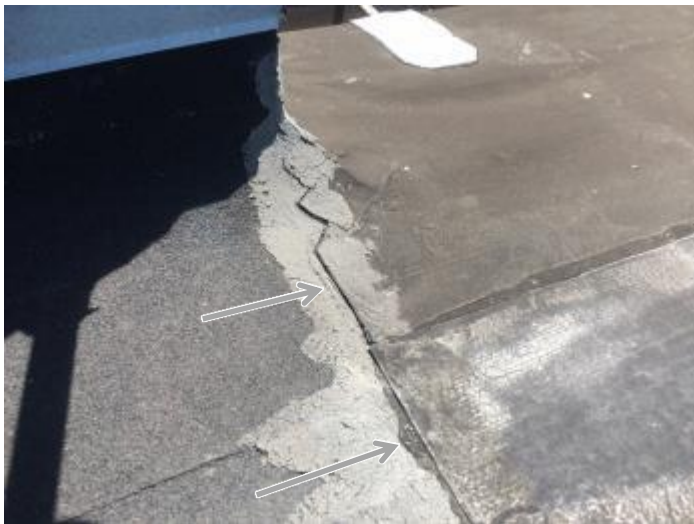
Seam failure at previous gutter edge repair at chimney area. This failure of adhesion appears to be due to lack of granular imbedding at the seam. Recommend repair seam, properly imbedding granulars in the process.
